## DUTY OF CARE: Tree Condition Survey & Report

**Client:** West Rainton Parish Council

**Site location:** West Rainton Cemetery

**Date:** 09/12/2025

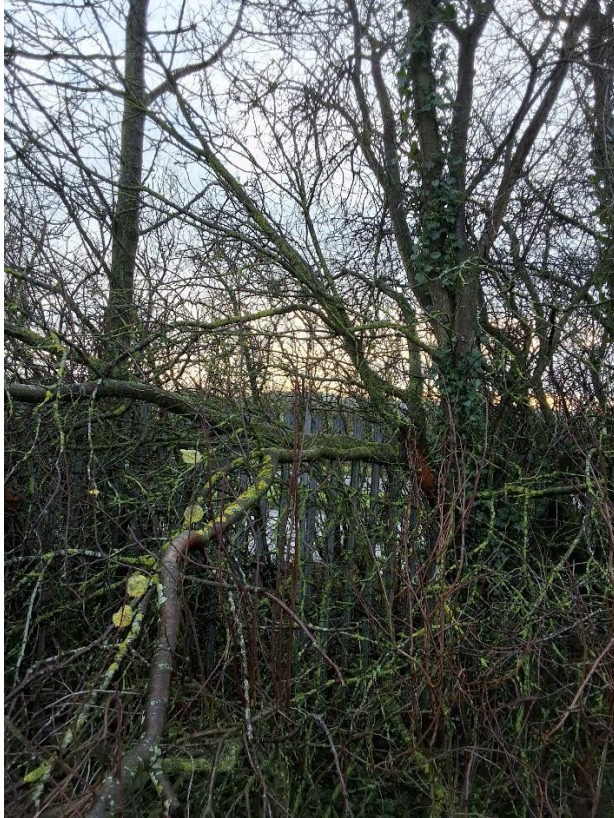
| T024 | Black cherry<br>( <i>Prunus serotina</i> ) | Semi Mature | 12 | 30 | Fair | Fair Crown Form and Condition<br>Recent snapped limb | Remove snapped limb | Moderate |

T024 – Snapped Limb

Crown lifting has been recommended for two trees (T010 and T013) to re-establish safe pedestrian access, and one tree T024 has a recent snapped limb requiring removal as a straightforward risk reduction measure. The mixed group (G001) and the majority of individual trees are not presently generating intervention needs beyond normal cyclical inspection, with no widespread indicators of significant physiological decline, basal instability, or systemic structural weakness within the site.

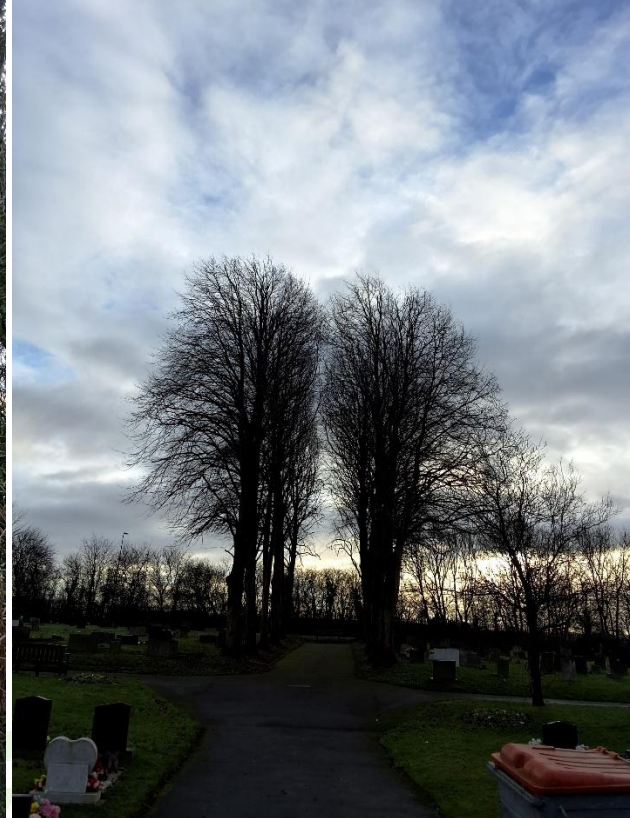
| T027 | Small-leaved lime<br>( <i>Tilia cordata</i> ) | Semi Mature | 15.5 | 45 | Good | Fair Crown Form and Condition<br>Deadwood in canopy >30mm, not atypical for species<br>Asymmetrical crown due to stand competition<br>Recently reduced to a very high standard | No action required at present | - |

T027-T038 – Stand of *Tilia*
